Service Bulletin

MEB09-2

MAIN LANDING GEAR TORQUE TUBE LIFE LIMIT

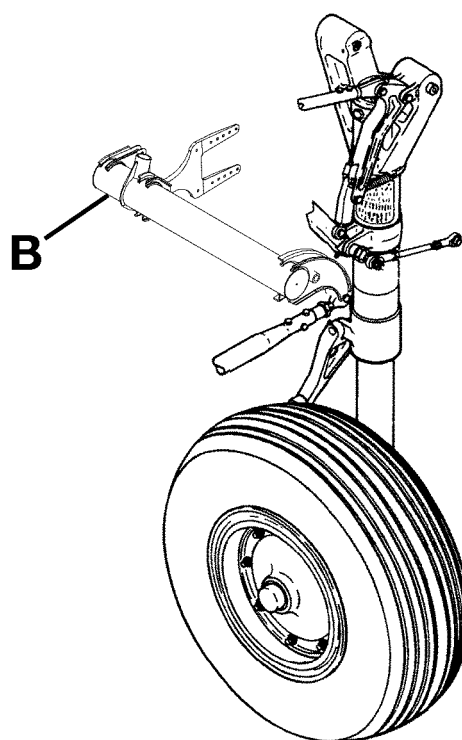
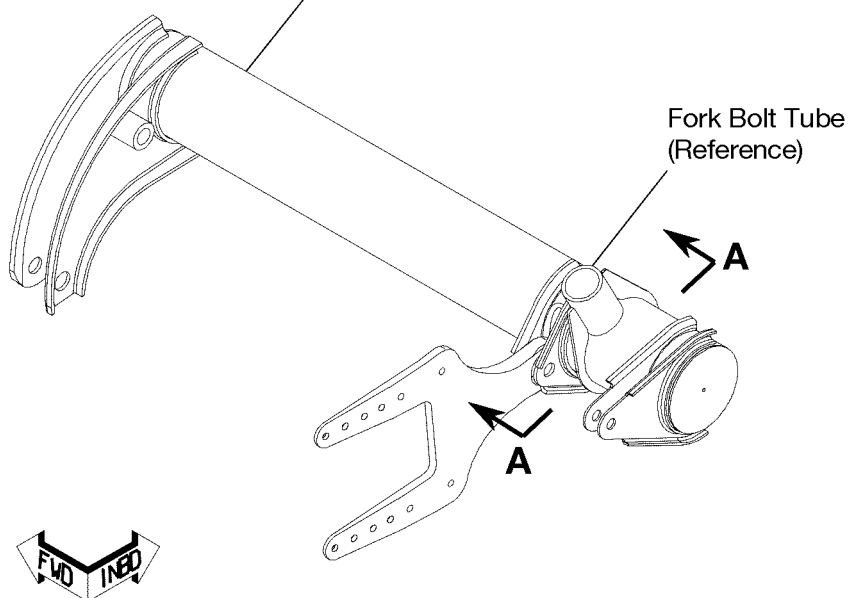
Figure 1. MLG Torque Tube Replacement (Sheet 1)

- B. (Refer to Figure 1, View A-A.) Examine the brace on the fork bolt tube.
 - (1) If there are no braces on the tube, the torque tube assembly installed on your airplane is not a 5045010-32 Right Torque Tube Assembly or a 5045010-33 Left Torque Tube Assembly. Go to Step 5.

- (3) If there are two braces on the tube, go to Step 4C.
 - C. Measure the outer diameter of the fork bolt tube:
 - (1) If the outer diameter of the tube is approximately 0.91 inch, the torque tube assembly installed on your airplane is a 5045010-32 Right Torque Tube Assembly or a 5045010-33 Left Torque Tube Assembly. Go to Step 9.

- (2) If the outer diameter of the tube is approximately 0.68 inch, the torque tube assembly installed on your airplane is not a 5045010-32 Right Torque Tube Assembly or a 5045010-33 Left Torque Tube Assembly. Go to Step 5.

5. Return the airplane to service as follows:
- A. Put the airplane on jacks. (Refer to the applicable section of the service/maintenance manual.)
 - B. (Refer to Figure 1, Detail A and Detail B.) Remove the 5045010 Torque Tube Assembly from the airplane. Keep the attachment hardware, but discard the nuts and the cotter pins. (Refer to the applicable section of the service/maintenance Manual.)

6. Install the 5045010-32 Right Torque Tube Assembly (5045010-33 Left Torque Tube Assembly) with the kept attachment hardware.
 - A. Do a visual inspection of the kept hardware that attaches the torque tube assembly to the outboard push-pull tube, uplock push-pull tube, support, 5027002-5 Support Bracket Assembly, and outboard drive tube.
